# Performance of Douglas fir in real outdoor use conditions

**Performances of Douglas fir in real outdoor use conditions**

Paper prepared for the 42<sup>nd</sup> Annual Meeting  
Queenstown, New Zealand  
8-12 May 2011

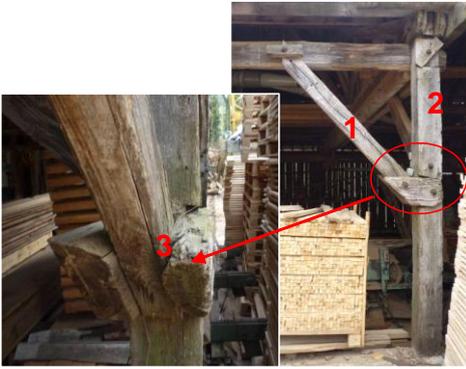
| age and description of the structure | service life parameters | result of the fungal decay investigation | | | | | | | | | | | | | | | | | | | | | |
|--|--|--|---|---|---|--|--|---|---|---|---|---|---|---|---|--|---|---|---|---|---|---|---|
| <p><b>sawmill</b><br/>date of construction:<br/>1950<br/>general description:<br/>outdoor carpentry elements</p> | <table border="1"> <thead> <tr> <th rowspan="2">Wood Thickness</th> <th rowspan="2">Design</th> <th>Climate</th> </tr> <tr> <th>MODERATE</th> </tr> <tr> <th colspan="2"></th> <th>Use Class</th> </tr> </thead> <tbody> <tr> <td rowspan="3">high</td> <td>Water draining</td> <td>3.a</td> </tr> <tr> <td>Intermediate</td> <td>3.b</td> </tr> <tr> <td>Water trapping</td> <td>3.b</td> </tr> </tbody> </table> <p style="text-align: right;">3      1-2</p> | Wood Thickness | Design | Climate | MODERATE | | | Use Class | high | Water draining | 3.a | Intermediate | 3.b | Water trapping | 3.b | <p>- posts<br/>wood sound</p> <p>- post to beam joints<br/>wood sound,<br/>some evidence of superficial decay in the wood-to-wood contact zone</p> | | | | | | | |

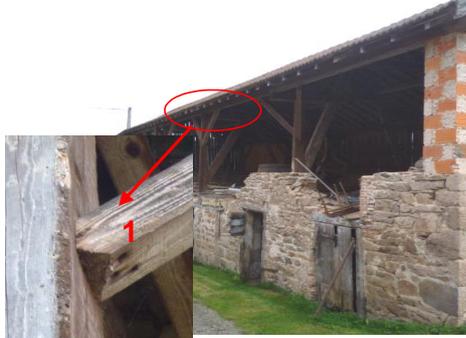
| age and description of the structure | service life parameters | result of the fungal decay investigation | | | | | | | | | | | | | | | | | | | | | |
|--|--|--|---|---|---|--|--|---|---|---|---|---|---|---|---|--|---|---|---|---|---|---|---|
| <p><b>farm building</b><br/>date of construction:<br/>1950<br/>general description:<br/>outdoor carpentry elements</p> | <table border="1"> <thead> <tr> <th rowspan="2">Wood Thickness</th> <th rowspan="2">Design</th> <th>Climate</th> </tr> <tr> <th>MODERATE</th> </tr> <tr> <th colspan="2"></th> <th>Use Class</th> </tr> </thead> <tbody> <tr> <td rowspan="3">high</td> <td>Water draining</td> <td>3.a</td> </tr> <tr> <td>Intermediate</td> <td>3.b</td> </tr> <tr> <td>Water trapping</td> <td>3.b</td> </tr> </tbody> </table> <p style="text-align: right;">2</p> | Wood Thickness | Design | Climate | MODERATE | | | Use Class | high | Water draining | 3.a | Intermediate | 3.b | Water trapping | 3.b | <p>- beams<br/>wood sound</p> <p>- post to beam joints<br/>wood sound</p> | | | | | | | |

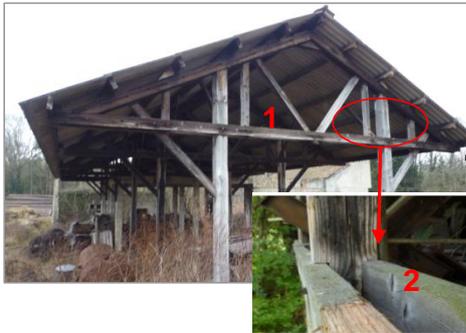
| age and description of the structure | service life parameters | result of the fungal decay investigation | | | | | | | | | | | | | | | | | | | | | |
|--|--|--|---|---|---|--|--|---|---|---|---|---|---|---|---|--|---|---|---|---|---|---|---|
| <p><b>farm building</b><br/>date of construction:<br/>1950<br/>general description:<br/>outdoor carpentry elements</p> | <table border="1"> <thead> <tr> <th rowspan="2">Wood Thickness</th> <th rowspan="2">Design</th> <th>Climate</th> </tr> <tr> <th>MODERATE</th> </tr> <tr> <th colspan="2"></th> <th>Use Class</th> </tr> </thead> <tbody> <tr> <td rowspan="3">high</td> <td>Water draining</td> <td>3.a</td> </tr> <tr> <td>Intermediate</td> <td>3.b</td> </tr> <tr> <td>Water trapping</td> <td>3.b</td> </tr> </tbody> </table> <p style="text-align: right;">1      2</p> | Wood Thickness | Design | Climate | MODERATE | | | Use Class | high | Water draining | 3.a | Intermediate | 3.b | Water trapping | 3.b | <p>- beams<br/>wood sound</p> <p>- post to beam joints<br/>wood sound</p> | | | | | | | |

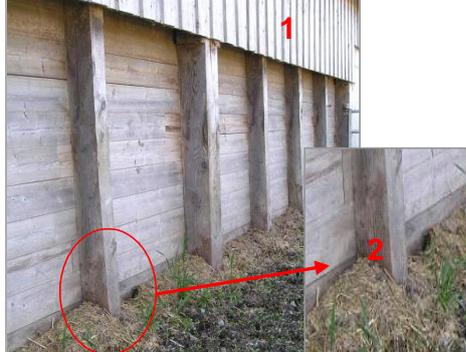
| age and description of the structure | service life parameters | result of the fungal decay investigation | | | | | | | | | | | | | | | | | | | | | |
|--|--|--|---|---|---|--|--|---|---|---|---|---|---|---|---|--|---|---|---|---|---|---|---|
| <p><b>farm building</b><br/>date of construction:<br/>2000<br/>general description:<br/>cladding<br/>outdoor carpentry</p> | <table border="1"> <thead> <tr> <th rowspan="2">Wood Thickness</th> <th rowspan="2">Design</th> <th>Climate</th> </tr> <tr> <th>MODERATE</th> </tr> <tr> <th colspan="2"></th> <th>Use Class</th> </tr> </thead> <tbody> <tr> <td rowspan="3">low</td> <td>Water draining</td> <td>3.a</td> </tr> <tr> <td>Intermediate</td> <td>3.a</td> </tr> <tr> <td>Water trapping</td> <td>3.b</td> </tr> <tr> <td rowspan="3">high</td> <td>Water draining</td> <td>3.a</td> </tr> <tr> <td>Intermediate</td> <td>3.b</td> </tr> <tr> <td>Water trapping</td> <td>3.b</td> </tr> </tbody> </table> <p style="text-align: right;">1      2</p> | Wood Thickness | Design | Climate | MODERATE | | | Use Class | low | Water draining | 3.a | Intermediate | 3.a | Water trapping | 3.b | high | Water draining | 3.a | Intermediate | 3.b | Water trapping | 3.b | <p>- cladding:<br/>wood sound</p> <p>- bottom part of the posts:<br/>wood sound</p> |

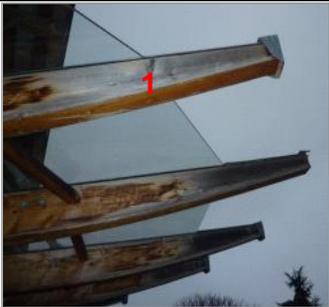
| age and description of the structure | | service life parameters | result of the fungal decay investigation | | | | | | | | | | | | |
|--|---|--|--|---|---|---|---|---|---|---|---|---|---|---|--|
| <p><b>school</b><br/>date of construction:<br/>1998<br/>general description:<br/>outdoor carpentry<br/>elements "pergola-like"</p> | | <table border="1"> <tr> <td rowspan="3">Wood Thickness</td> <td rowspan="3">Design</td> <td>Climate</td> </tr> <tr> <td>MODERATE</td> </tr> <tr> <td>Use Class</td> </tr> <tr> <td rowspan="3">high</td> <td>Water draining</td> <td>3.a</td> </tr> <tr> <td>Intermediate</td> <td>3.b</td> </tr> <tr> <td>Water trapping</td> <td>3.b</td> </tr> </table> <p style="text-align: center;">1                      2</p> | Wood Thickness | Design | Climate | MODERATE | Use Class | high | Water draining | 3.a | Intermediate | 3.b | Water trapping | 3.b | <p>- horizontal beams<br/>wood sound</p> <p>- bottom part of the posts<br/>wood sound</p> |

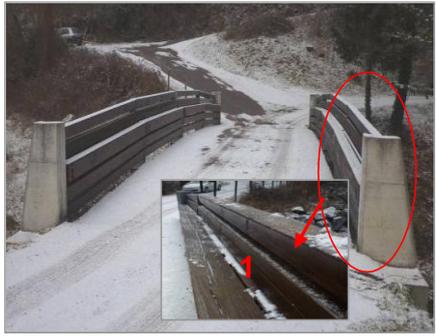
| age and description of the structure | | service life parameters | result of the fungal decay investigation | | | | | | | | | | | | |
|--|---|--|--|---|---|---|---|---|---|---|---|---|---|---|--|
| <p><b>bridge</b><br/>date of construction:<br/>2000<br/>general description:</p> | | <table border="1"> <tr> <td rowspan="3">Wood Thickness</td> <td rowspan="3">Design</td> <td>Climate</td> </tr> <tr> <td>WET</td> </tr> <tr> <td>Use Class</td> </tr> <tr> <td rowspan="3">high</td> <td>Water draining</td> <td>3.b</td> </tr> <tr> <td>Intermediate</td> <td>4</td> </tr> <tr> <td>Water trapping</td> <td>4</td> </tr> </table> <p style="text-align: center;">1</p> | Wood Thickness | Design | Climate | WET | Use Class | high | Water draining | 3.b | Intermediate | 4 | Water trapping | 4 | <p>- balustrade<br/>decay initiated locally (close to the nodes)</p> |

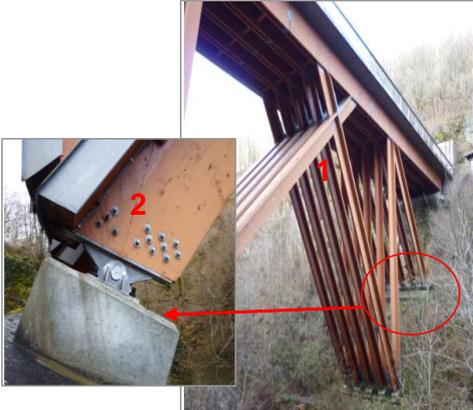
| age and description of the structure | | service life parameters | result of the fungal decay investigation | | | | | | | | | | | | |
|--|---|--|--|---|---|---|---|---|---|---|---|---|---|---|--|
| <p><b>bridge</b><br/>date of construction:<br/>1998<br/>general description:<br/>glue-lamed structure</p> | | <table border="1"> <tr> <td rowspan="3">Wood Thickness</td> <td rowspan="3">Design</td> <td>Climate</td> </tr> <tr> <td>WET</td> </tr> <tr> <td>Use Class</td> </tr> <tr> <td rowspan="3">high</td> <td>Water draining</td> <td>3.b</td> </tr> <tr> <td>Intermediate</td> <td>4</td> </tr> <tr> <td>Water trapping</td> <td>4</td> </tr> </table> <p style="text-align: center;">1                      2</p> | Wood Thickness | Design | Climate | WET | Use Class | high | Water draining | 3.b | Intermediate | 4 | Water trapping | 4 | <p>glue-lamed structure:<br/>wood sound</p> <p>- post to beam assembly:<br/>wood sound</p> |
